Micro Climates and Moisture Induced Damage to Paintings

Marion F. Mecklenburg

**Smithsonian Museum Conservation Institute
Washington, D.C.**

Copenhagen, November 19, 2007

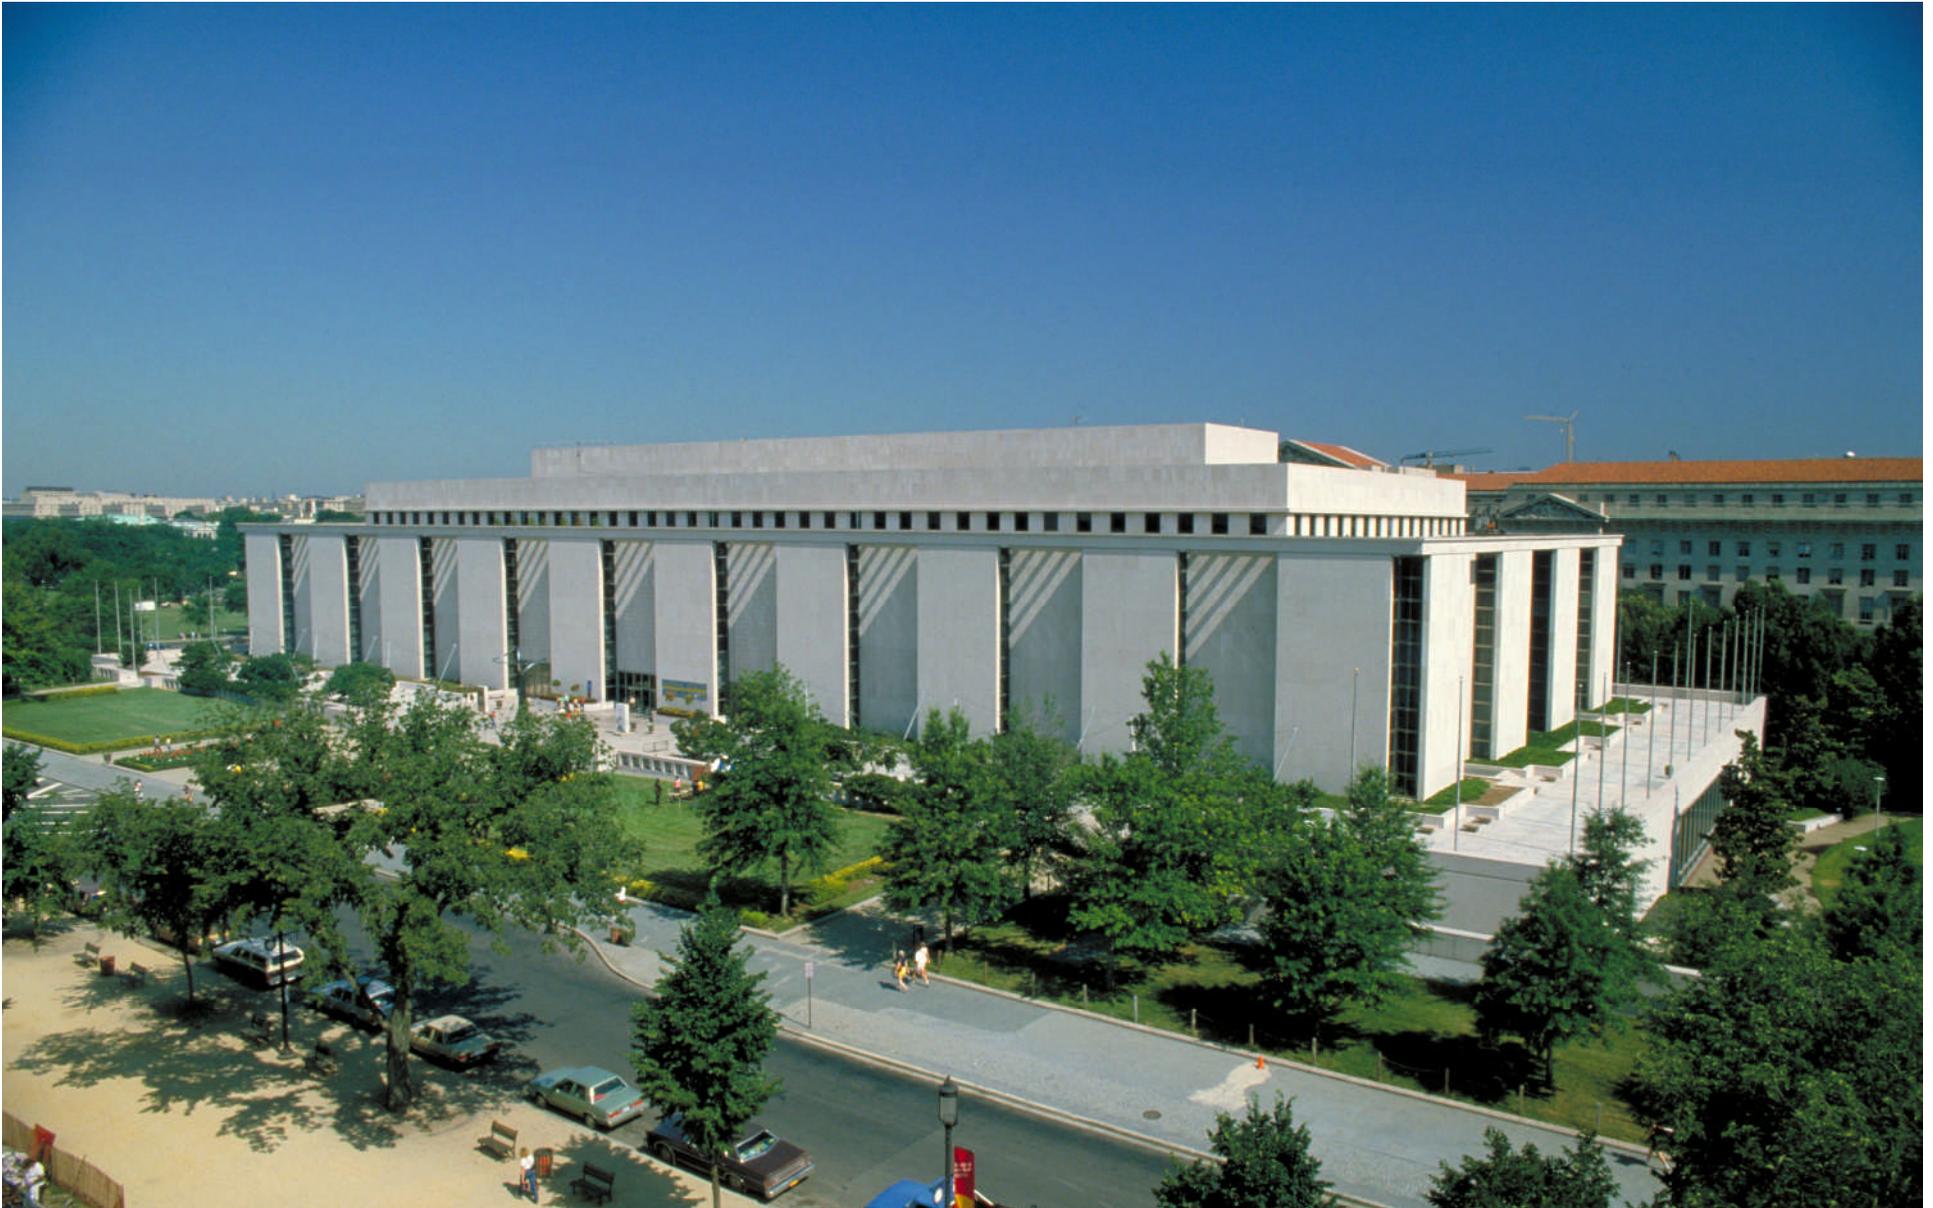
The National Museum of American History, c 1960's

**The National Museum of American History, c 1960's
Condensing moisture due to high relative humidity
(50%) In the wintertime.**

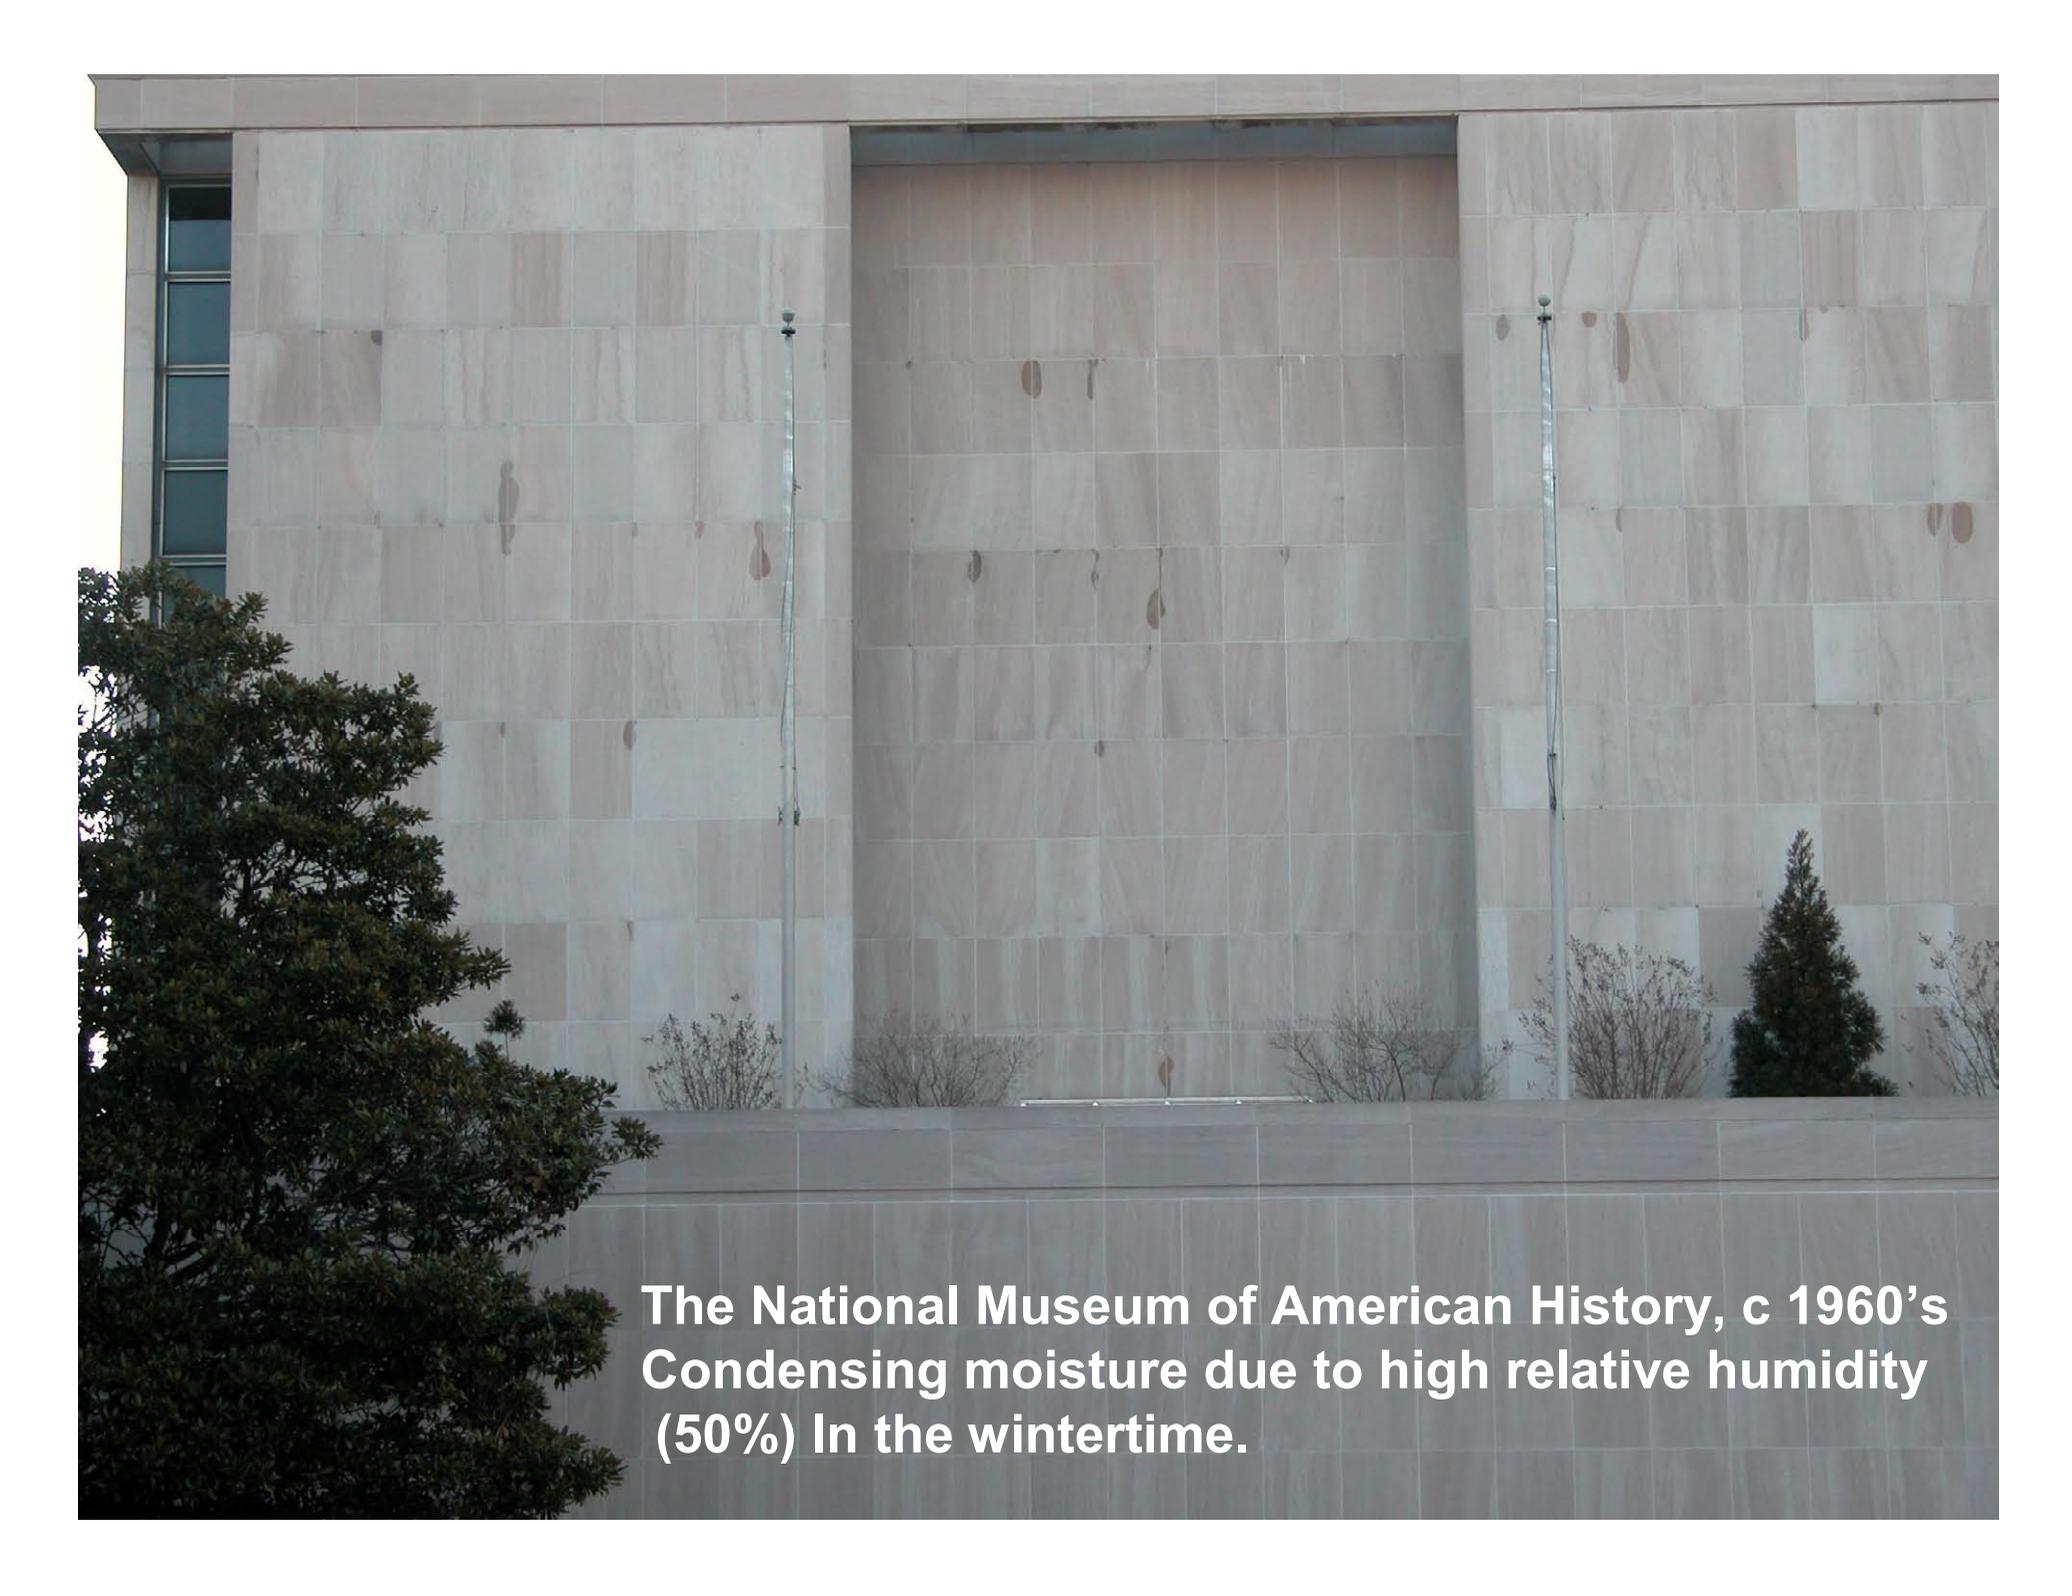
The image shows a close-up of the exterior wall of the National Museum of American History. The wall is constructed from large, light-colored rectangular stone blocks. A prominent feature is the presence of numerous brownish, teardrop-shaped stains of condensation scattered across the stone surface, particularly in the central recessed area and along vertical lines. Two vertical metal pipes or conduits run down the wall, one on the left and one on the right of the central recessed section. To the left, a portion of a dark green tree is visible. At the bottom, there are some bare, brown shrubs. The overall lighting is somewhat dim, suggesting an overcast day or late afternoon.

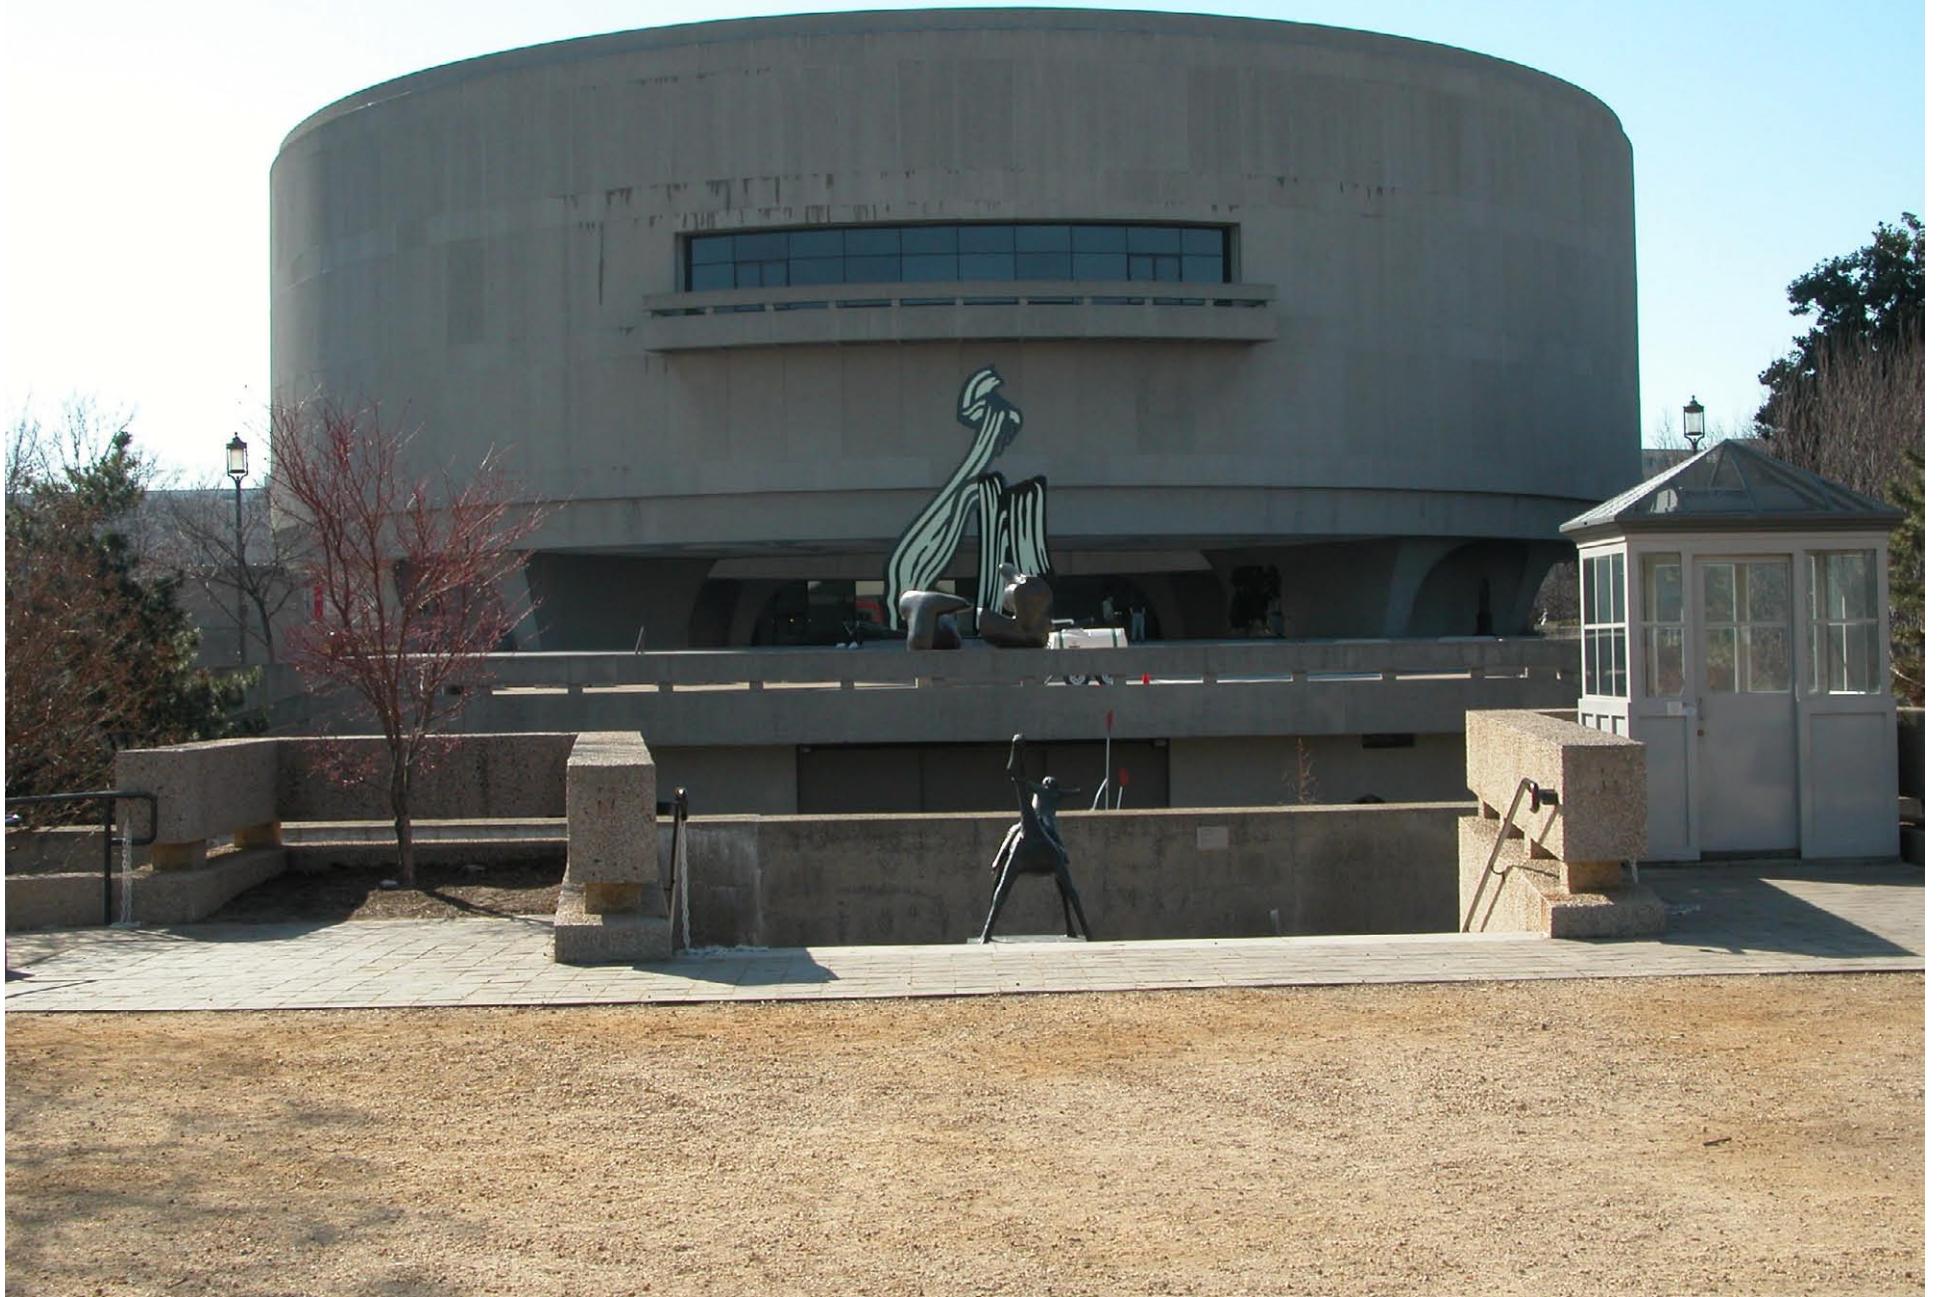
The Hirshhorn Museum, 1970's

Moisture penetration through wall systems. The leaks are a result of condensing moisture in the wall in the wintertime and structural settlement over the balcony area

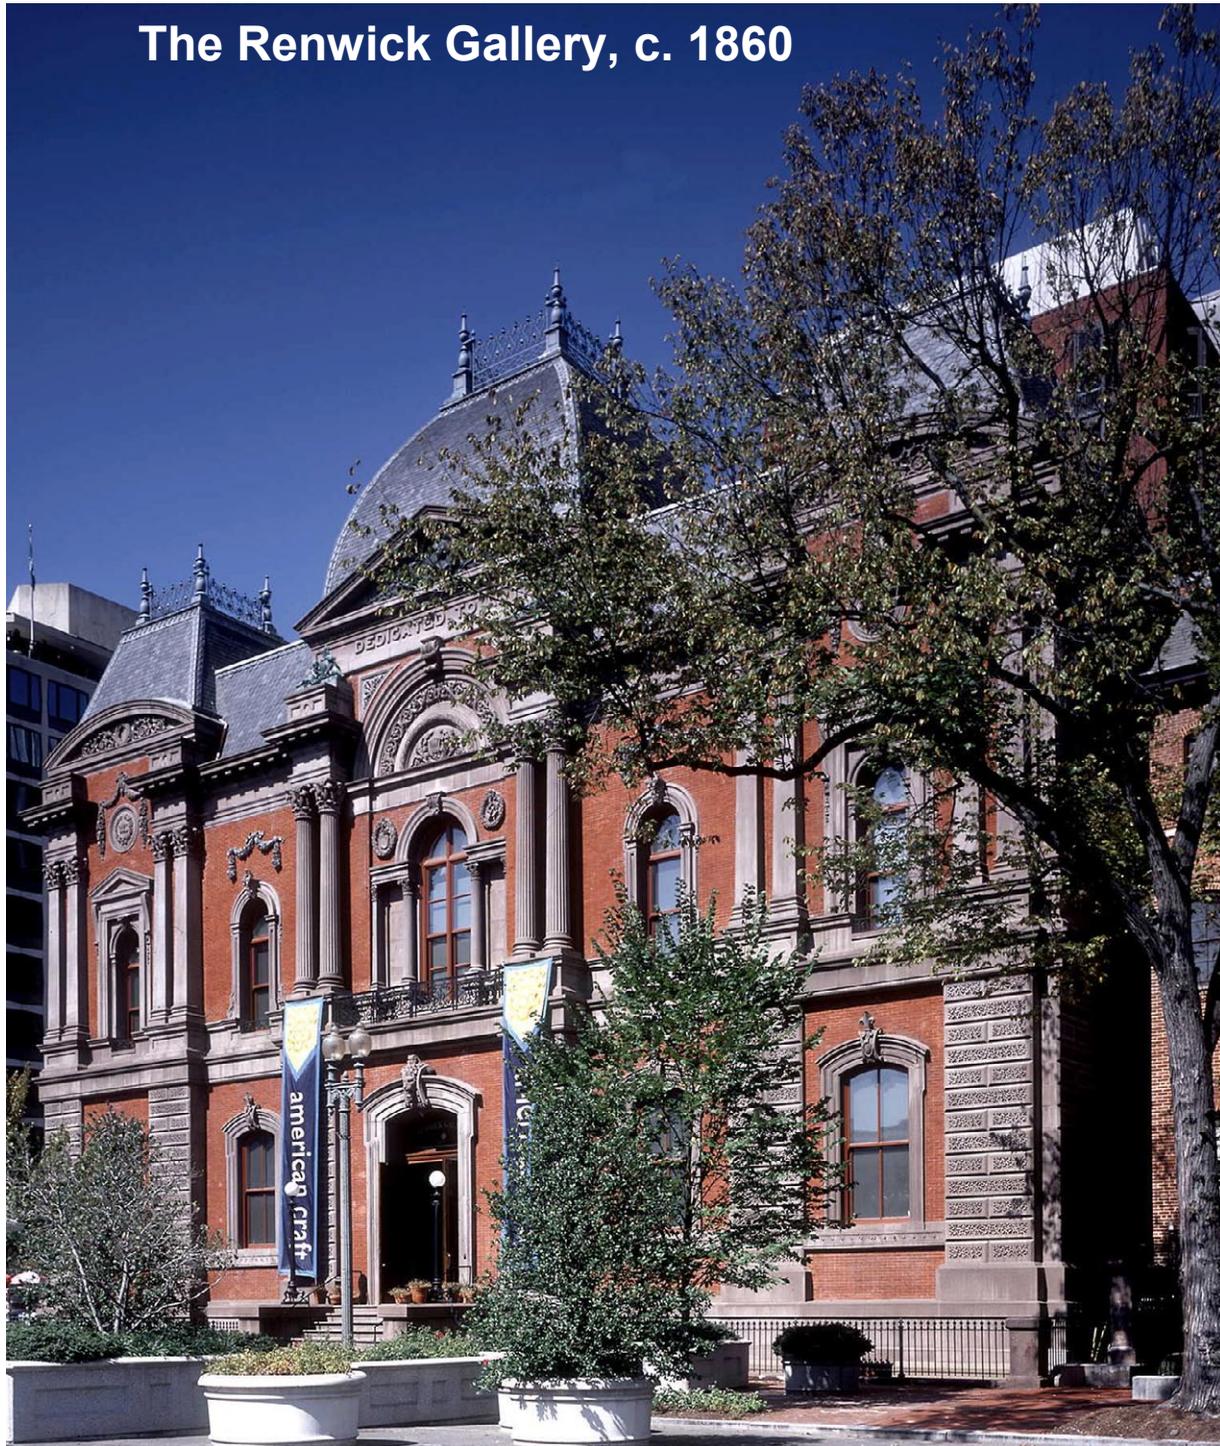
The Renwick Gallery, c. 1860

Moisture condensation on the walls in cold winters. Indoor ambient relative humidity was 50%. In the hot summertime RH drop to 35% behind the painting.

- Reset the museum environment, lower the RH in the wintertime to 37% RH - 40% RH**
- Provide backing boards to all paintings**
- Provide a 25mm - 50mm airspace behind all paintings on the inside of exterior walls.**

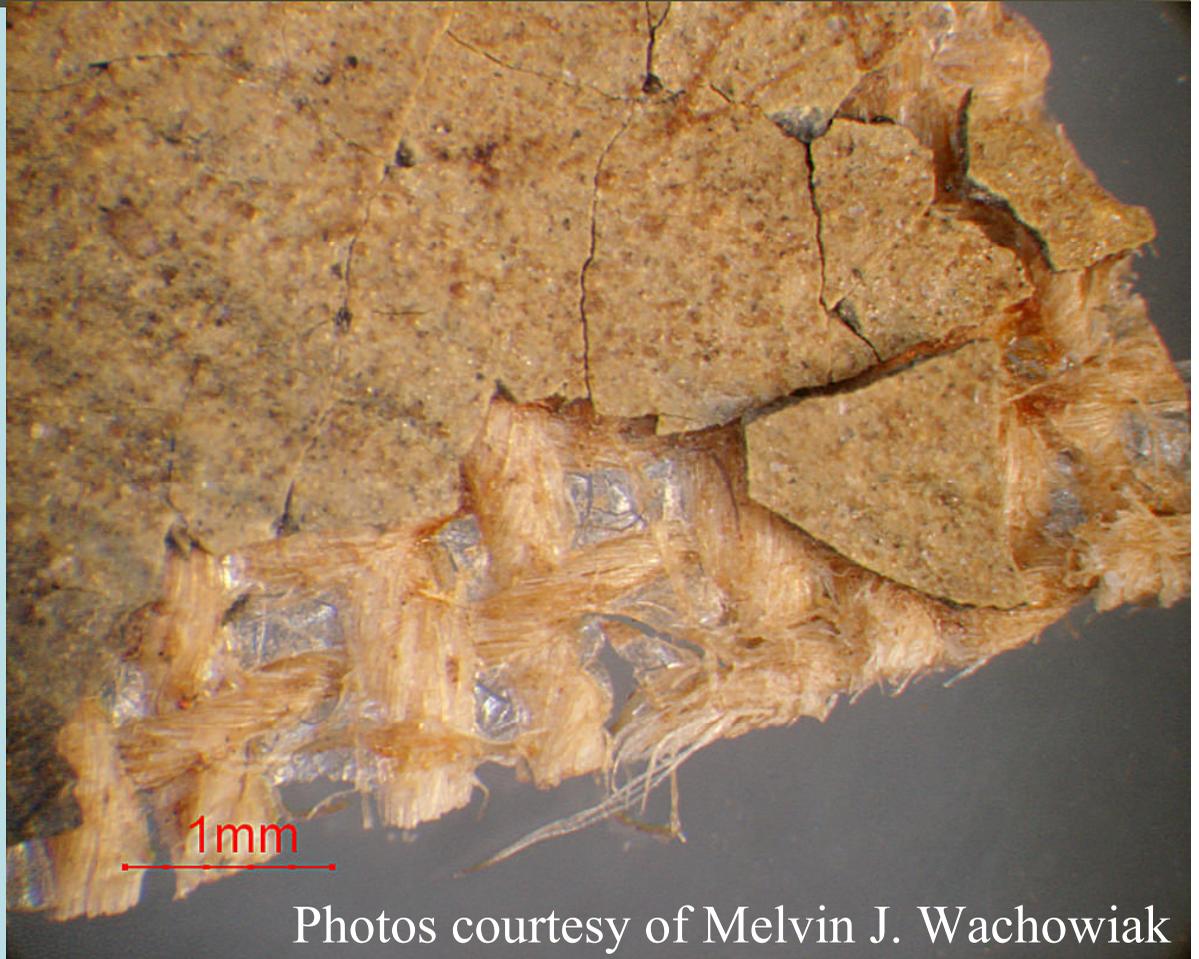
**19th century Italian
oil on canvas.**

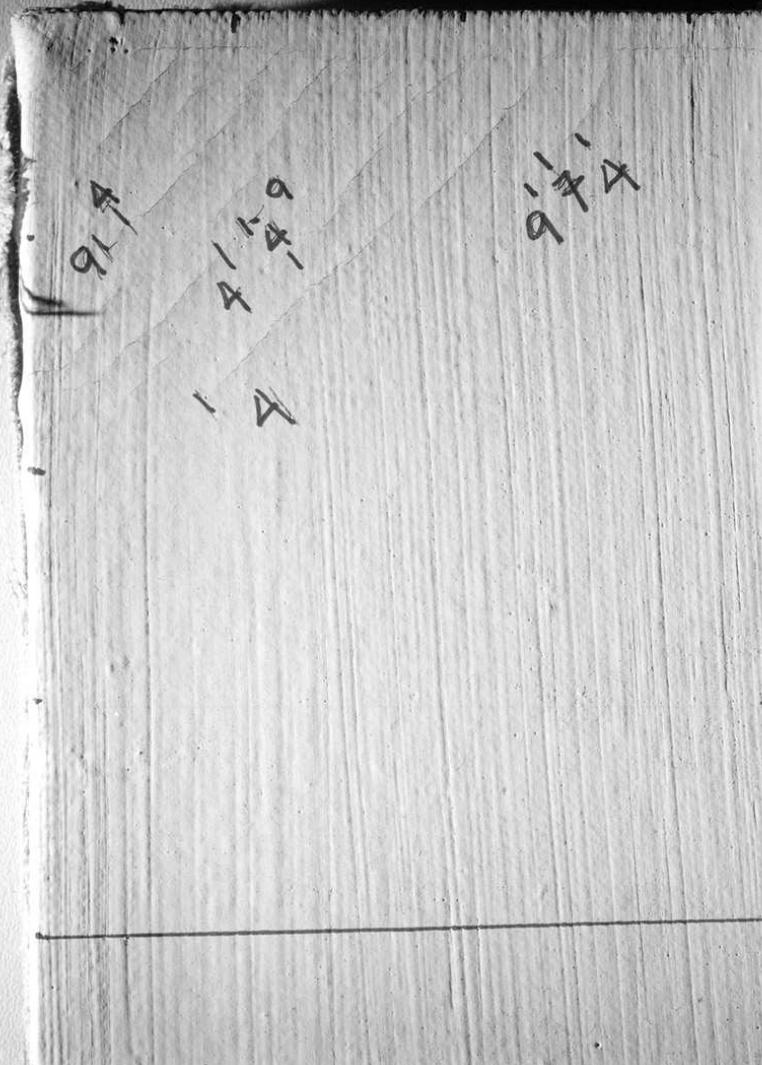
75 mm

Cycling painting in large RH ranges.

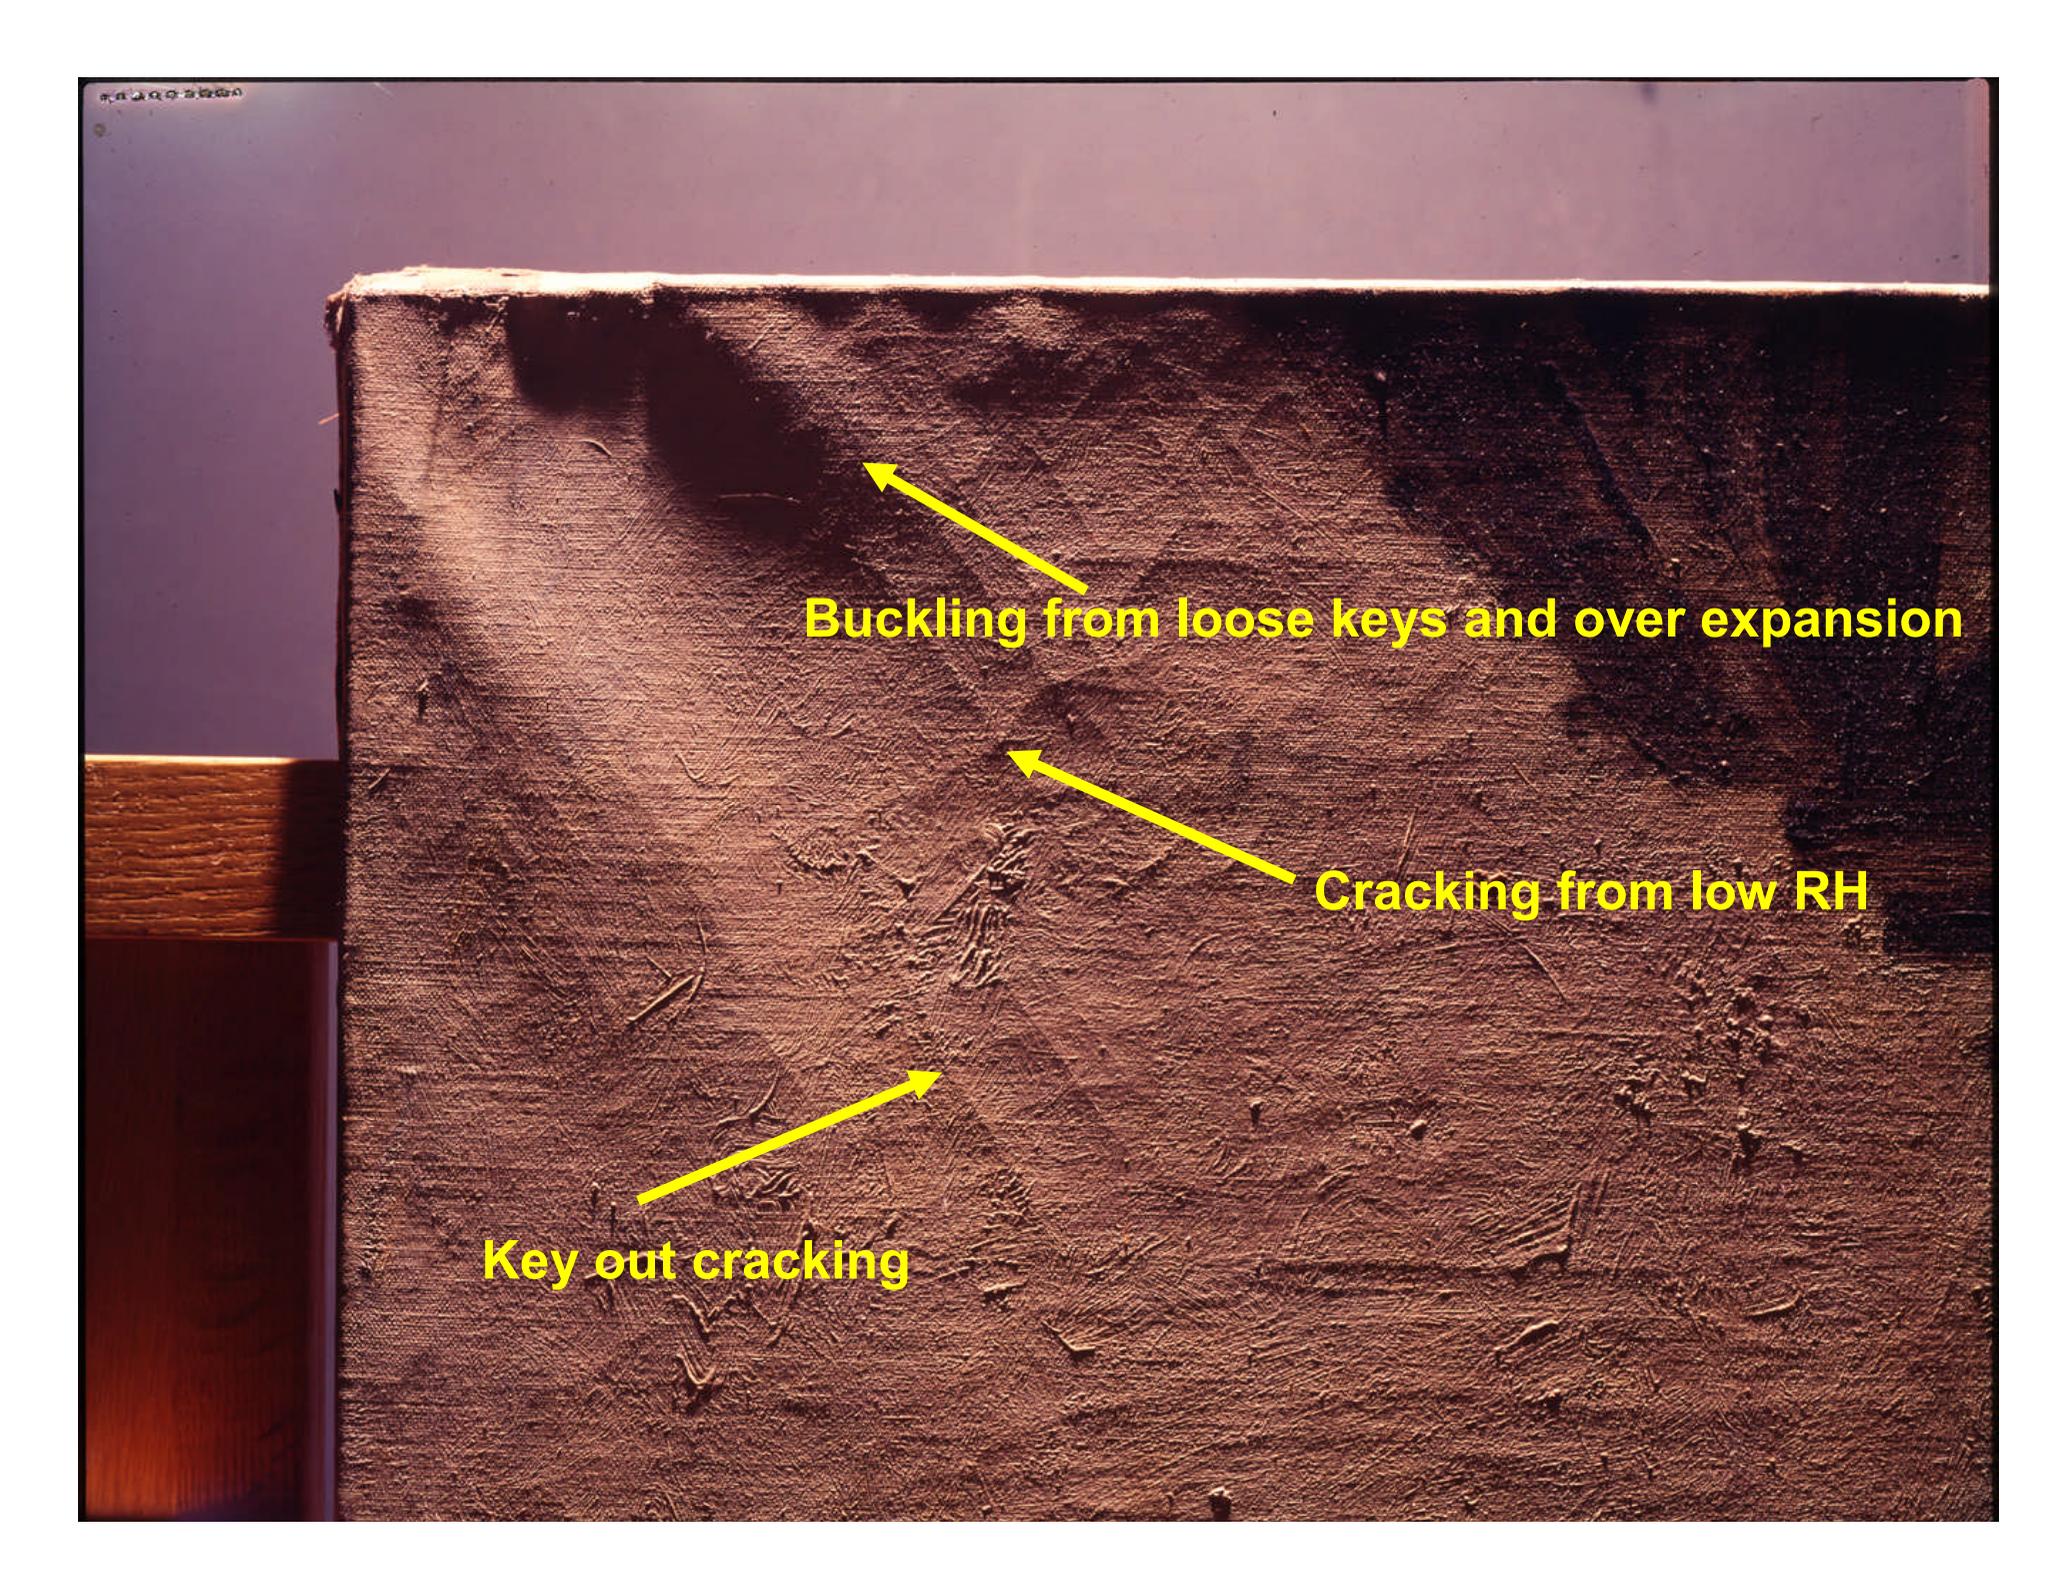
A close-up photograph of a book cover, likely made of a textured material like cloth or leatherette. The cover shows significant wear and damage. Three yellow arrows point to specific areas of damage: one at the top left pointing to a buckled area, one in the center pointing to a cracked area, and one at the bottom left pointing to a cracked area. The text labels are in yellow. The background is dark and out of focus.

Buckling from loose keys and over expansion

Cracking from low RH

Key out cracking

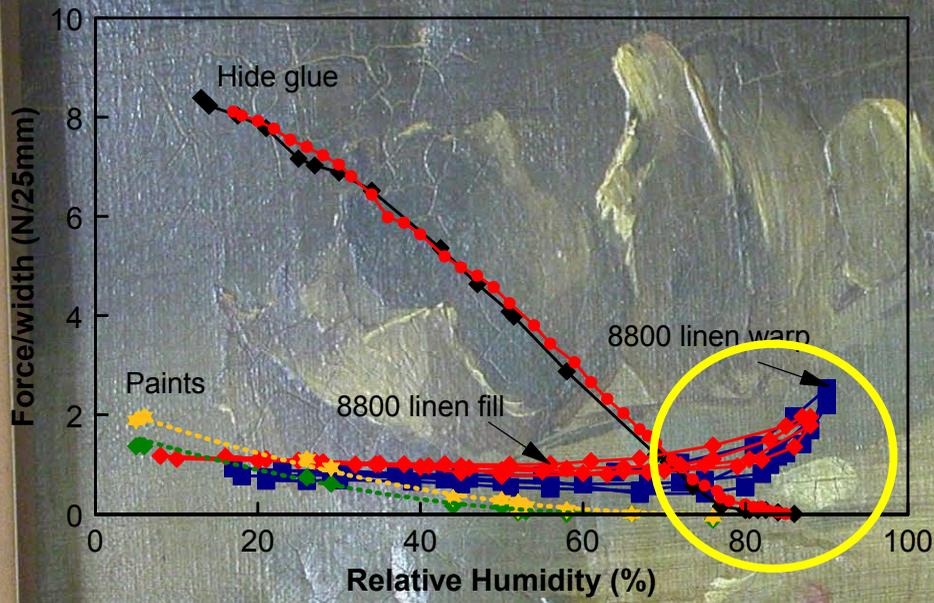
High moisture damage

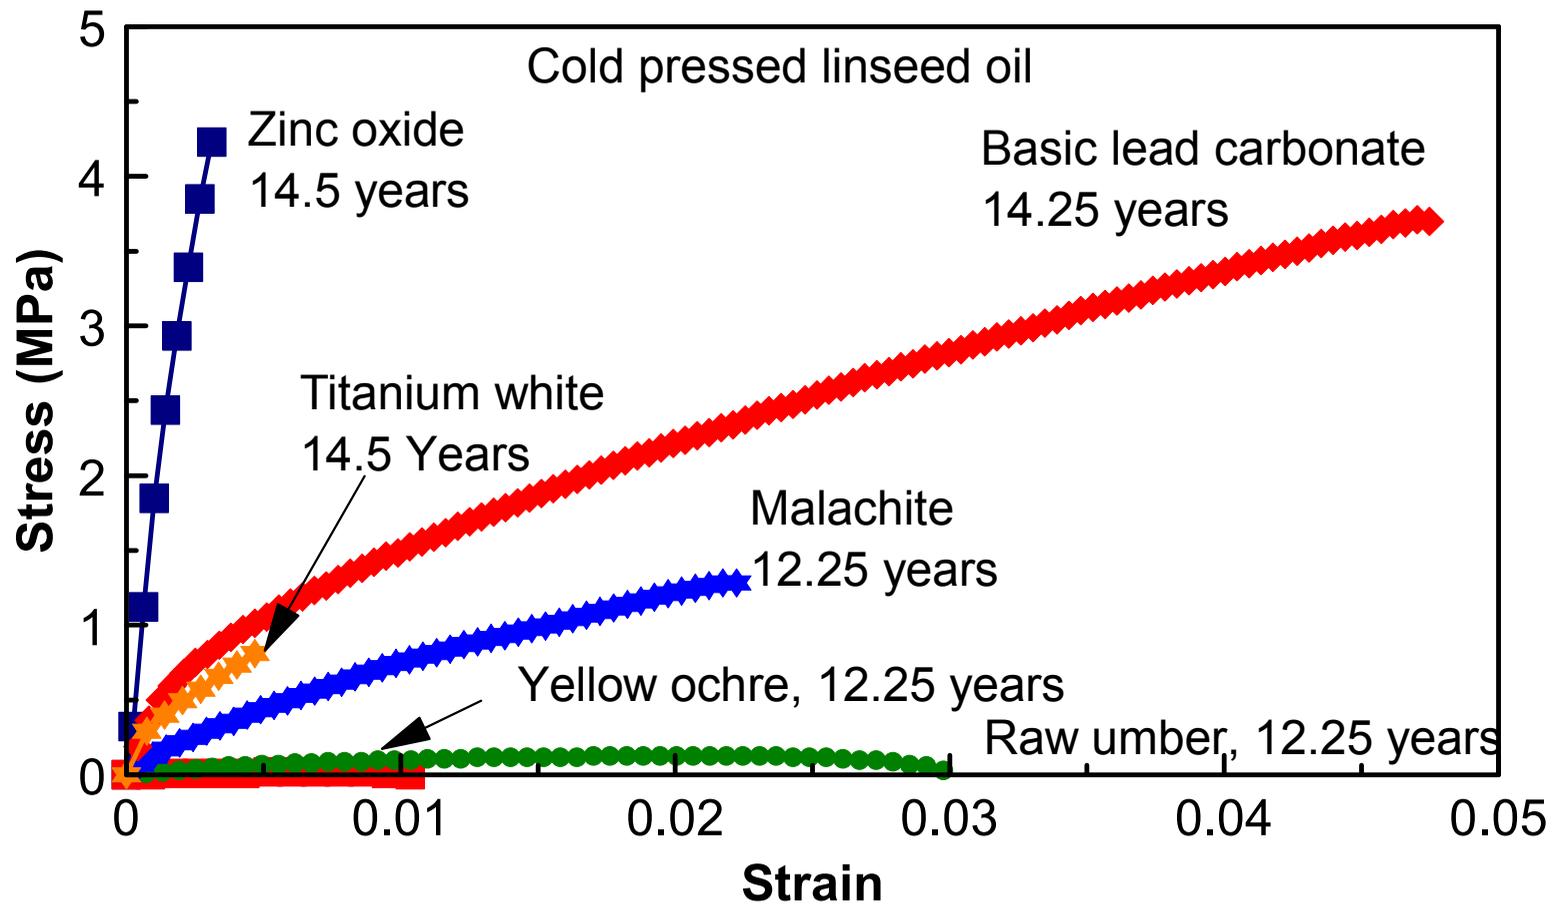
The strength of the oil paints made with different pigments

Paints tested at 48% RH, 23 C

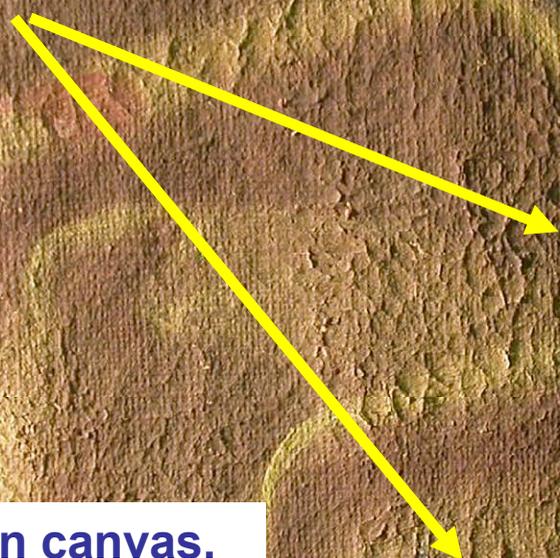
**19th Cent. Italian, oil on canvas.
Damage is due to high moisture
levels**
